Electrical Inspection Report

Client – Shayne & Marlise Sparks

**Inspection Carried Out on 10/01/2024. Electrical Inspection & Assessment
for Property at 39 Douglas Street – South Dunedin - DUNEDIN**

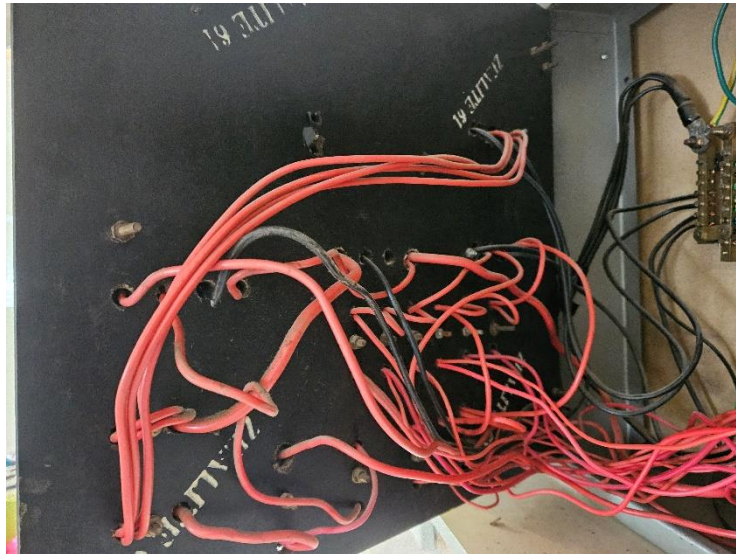
D1

The switchboard panel to main switchboard may potentially contain asbestos materials.

I would recommend no new work be carried out on the Switchboard (which requires drilling or cutting the panel), until further investigation is carried out.
